2023 Facility Assessment Overview

September 13, 2023

PARTNERS in Architecture

L'Anse Creuse Public Schools – 2023 Facility Assessment

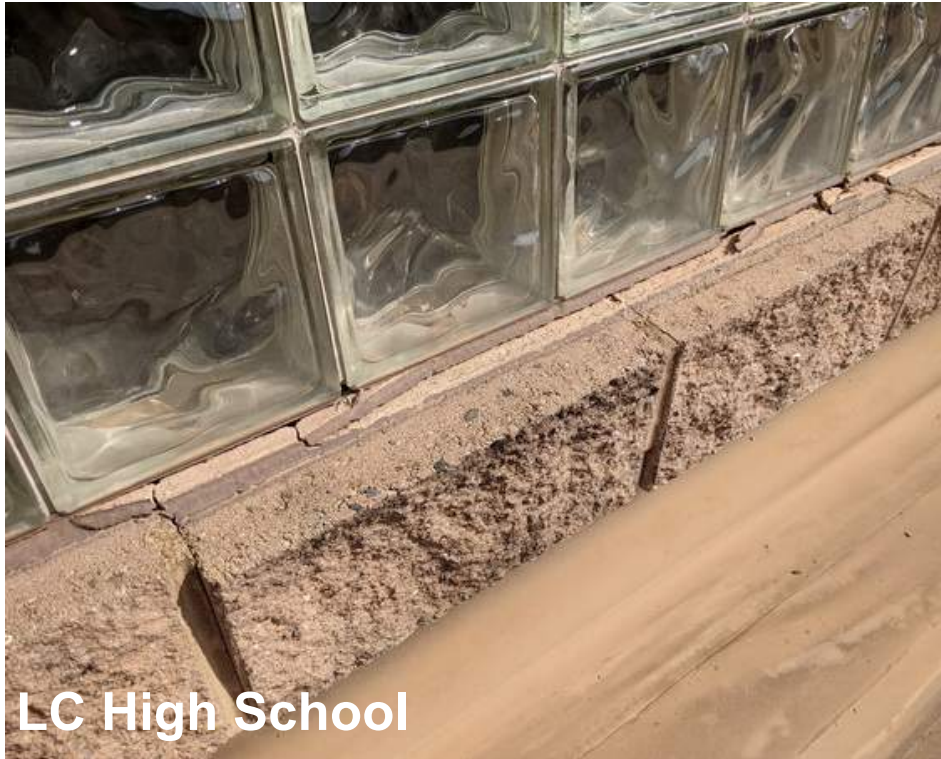
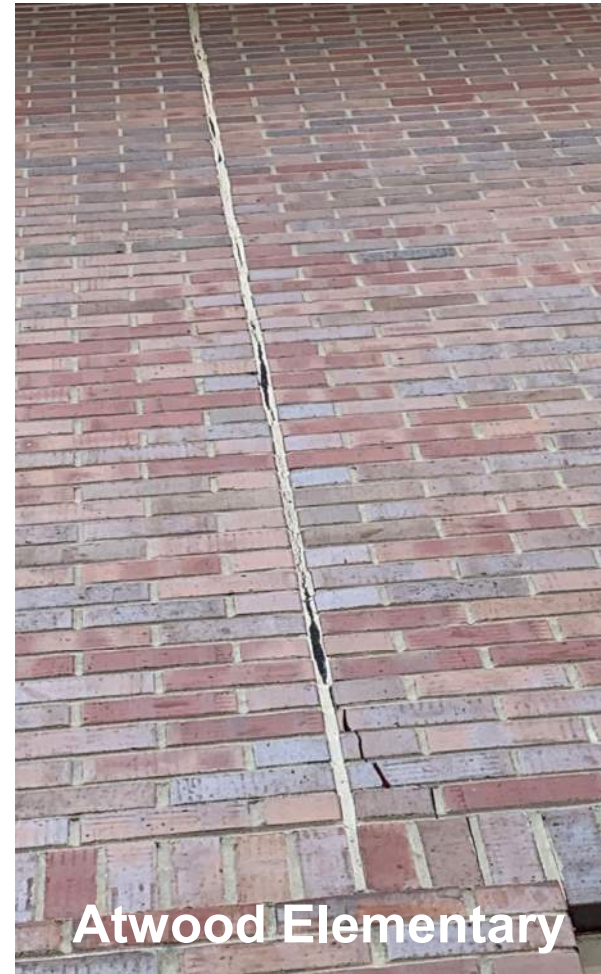
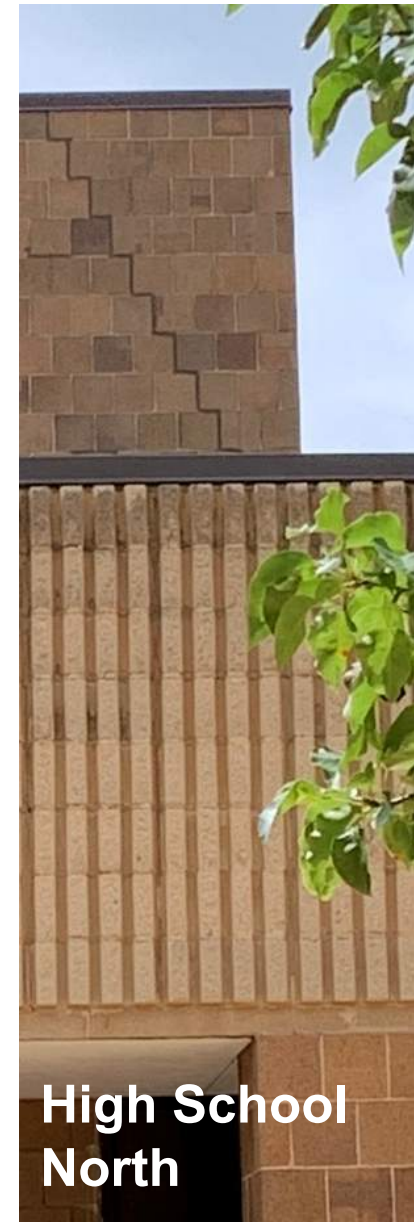
- **Exterior Envelope:**
deteriorated / spalling brick
veneer, step cracking @
masonry, deteriorated
mortar & expansion joints

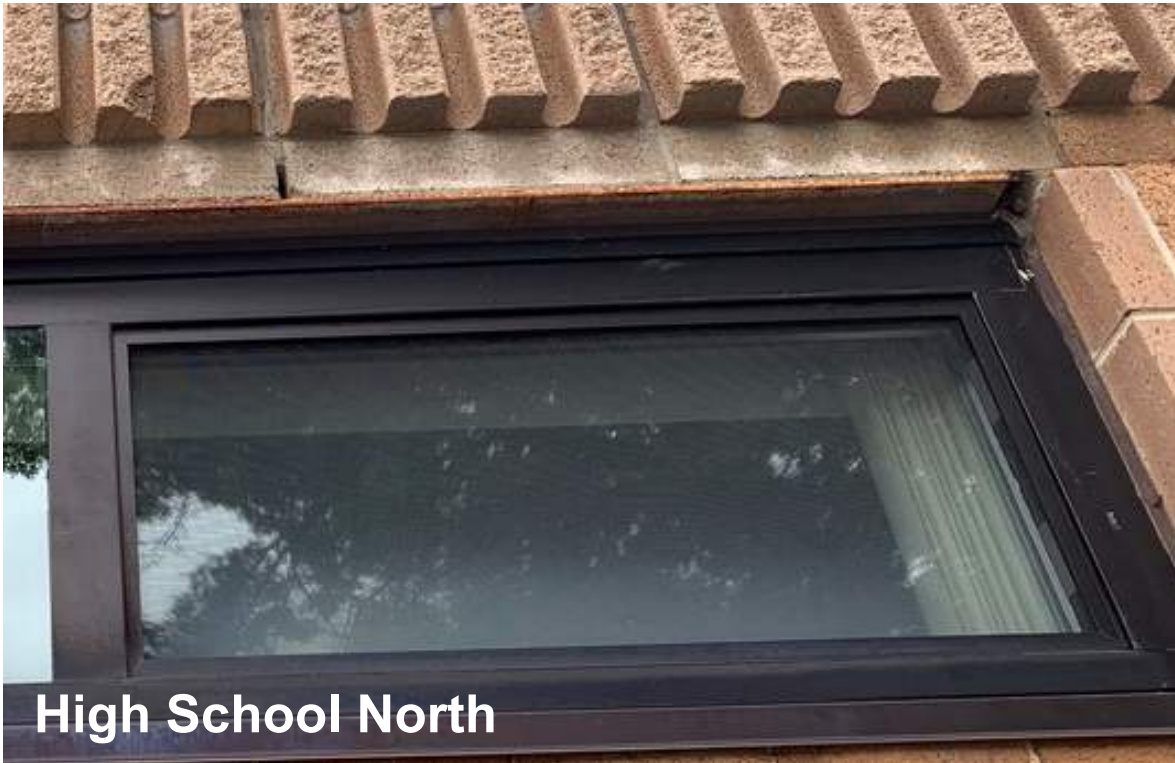
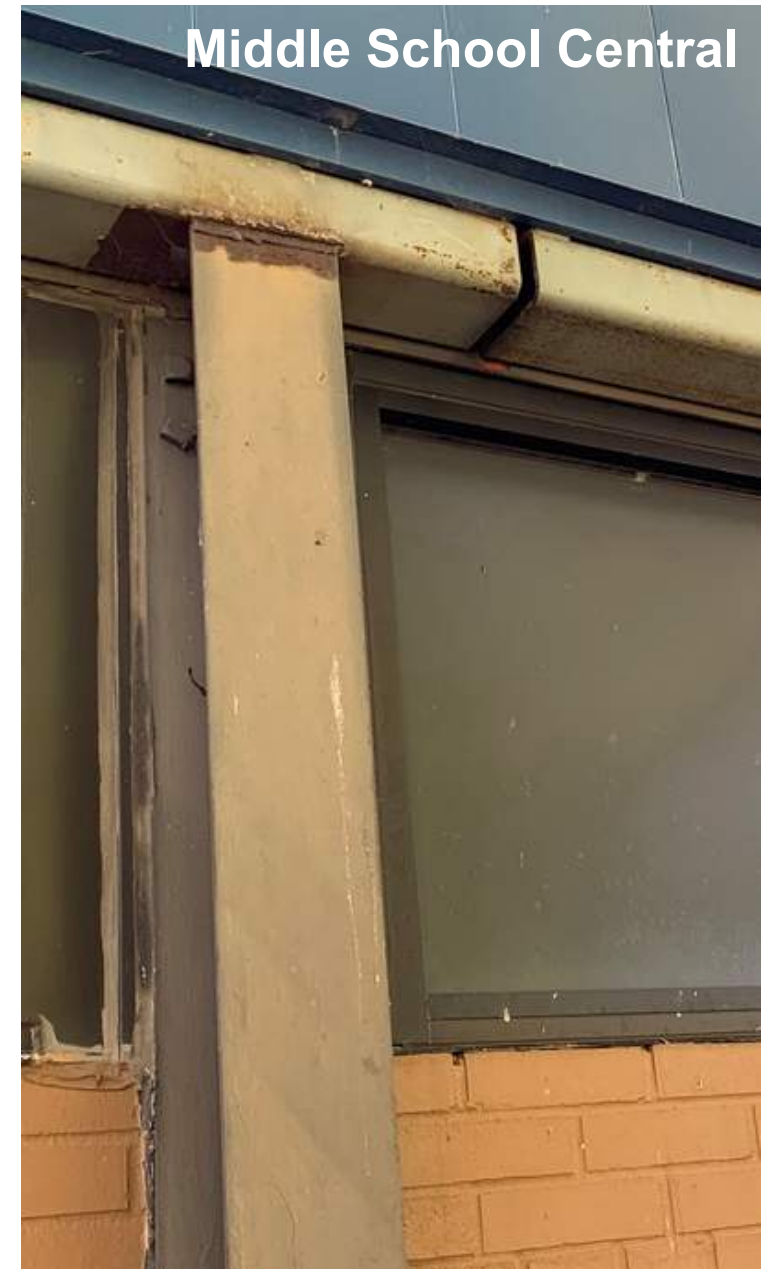
- **Exterior Envelope:** Rusting steel lintels & exposed steel framing

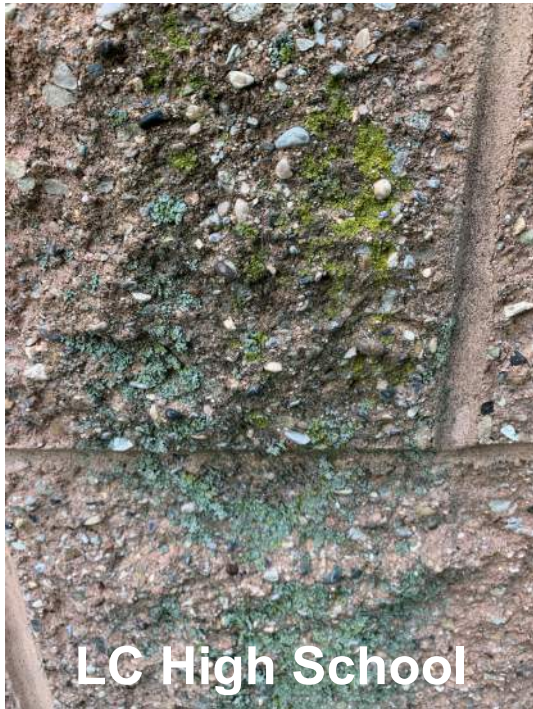
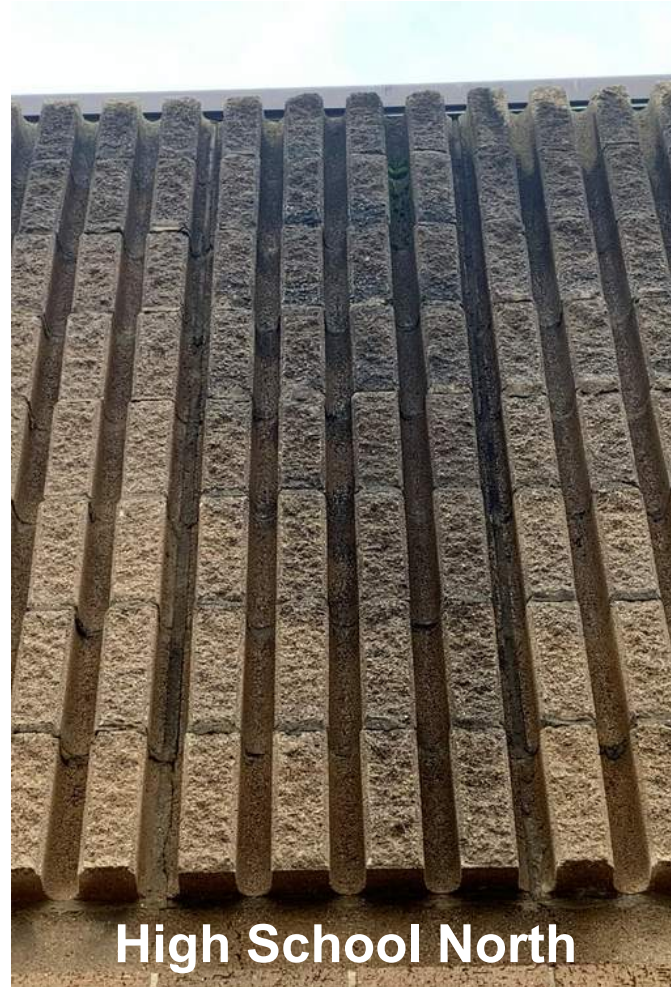
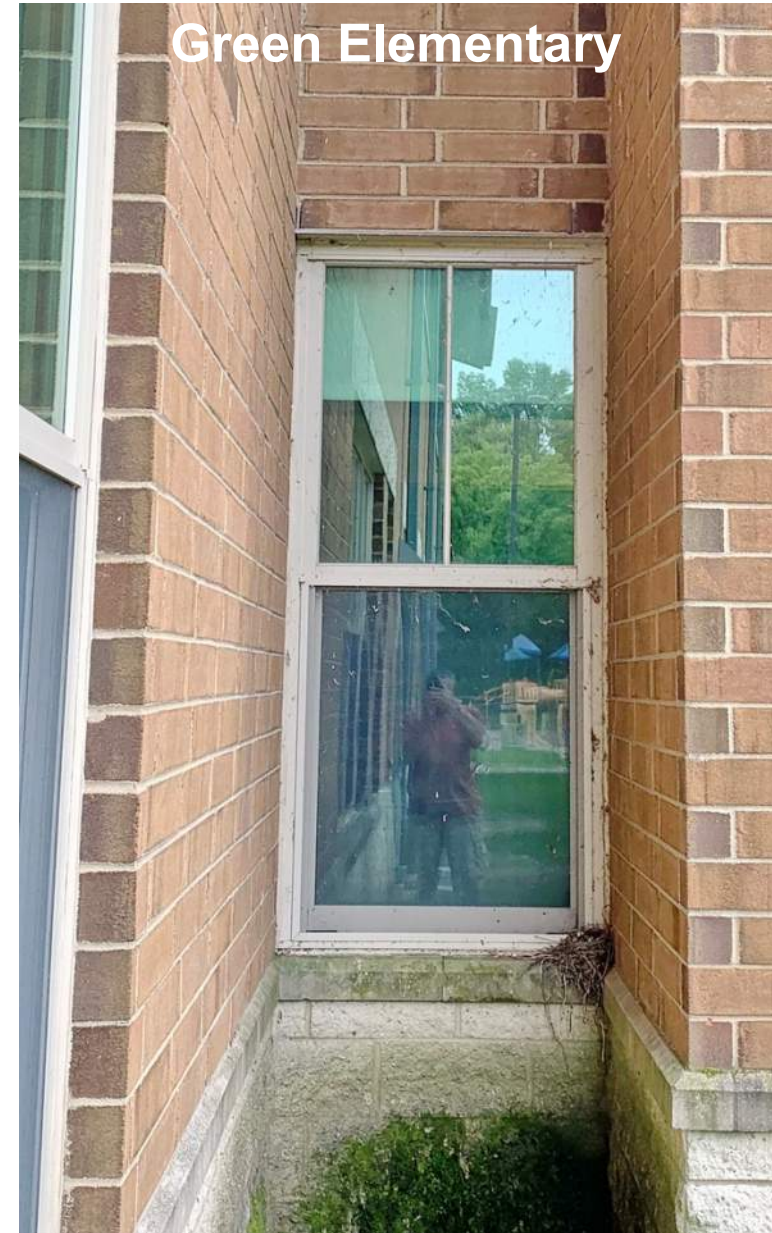
- **Exterior Envelope:** Masonry staining / discoloration, moisture issues

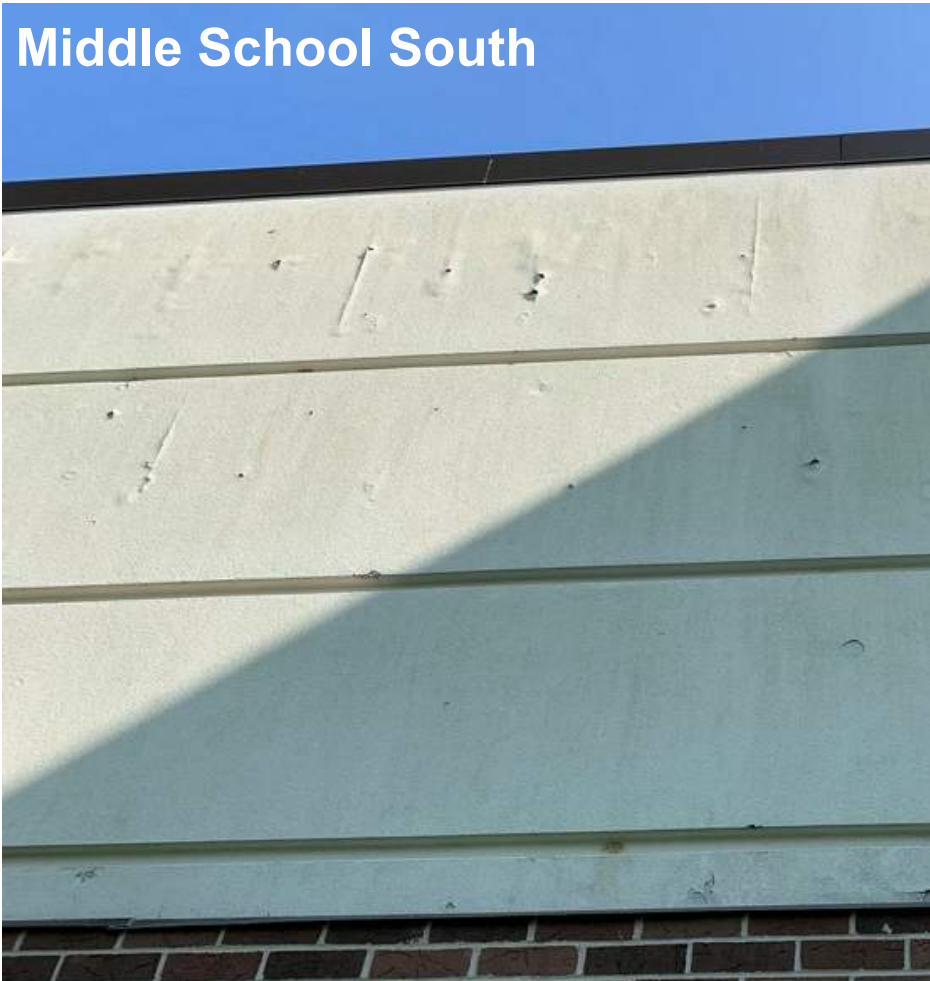
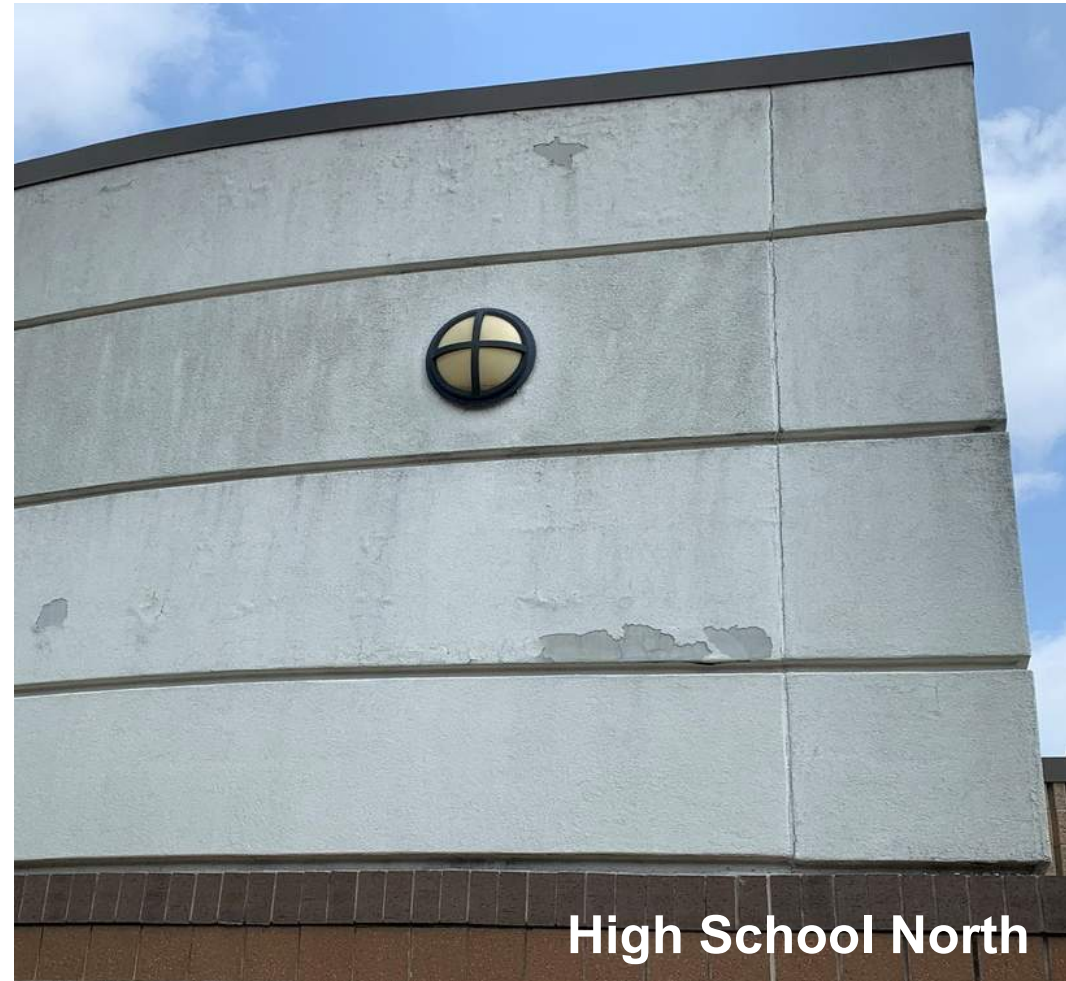
- **Exterior Envelope: EIFS deterioration**

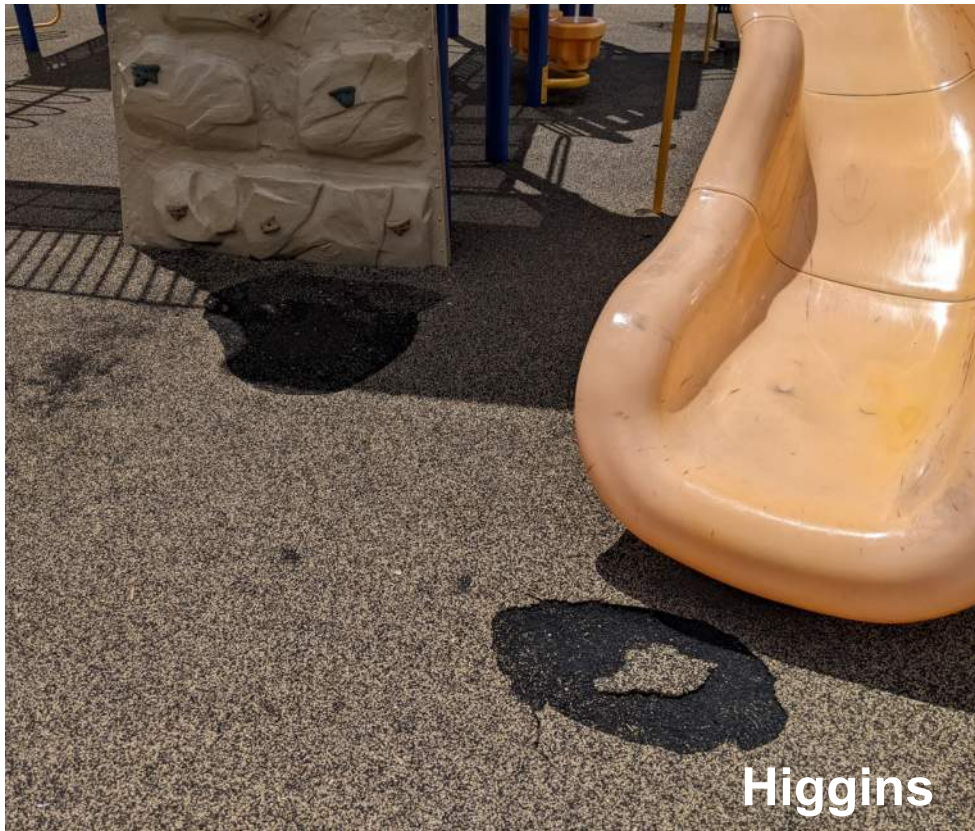
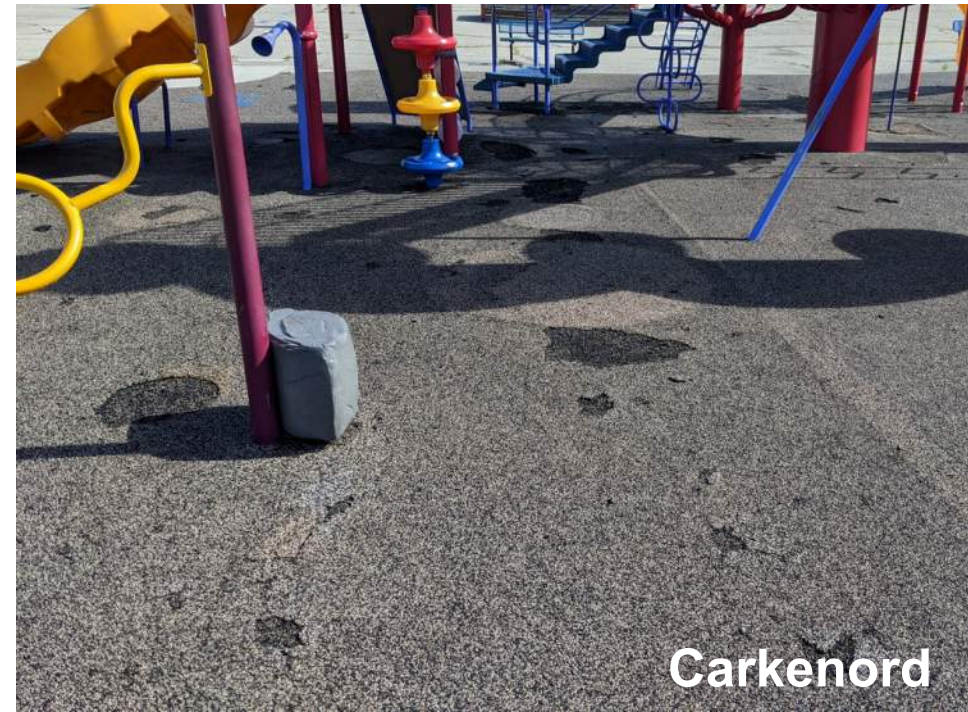
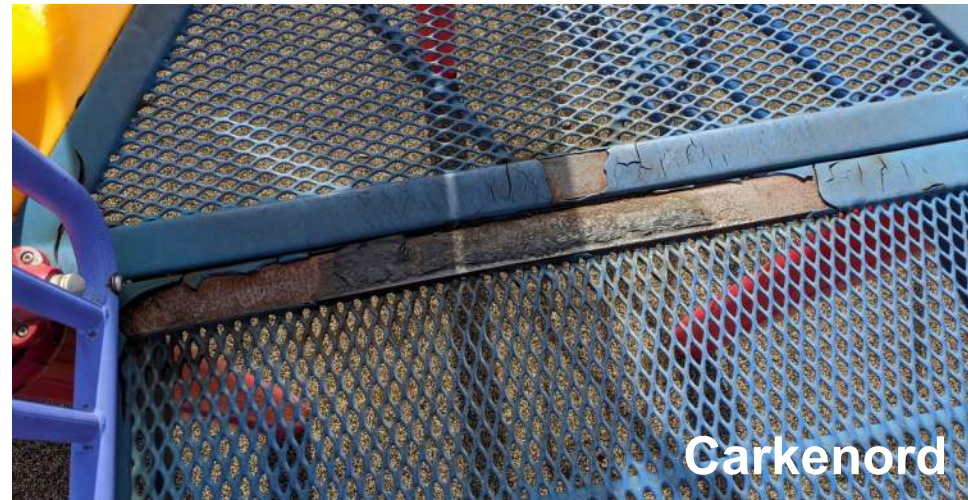
- **Playgrounds:** Deteriorated rubberized surfacing, rusting equipment

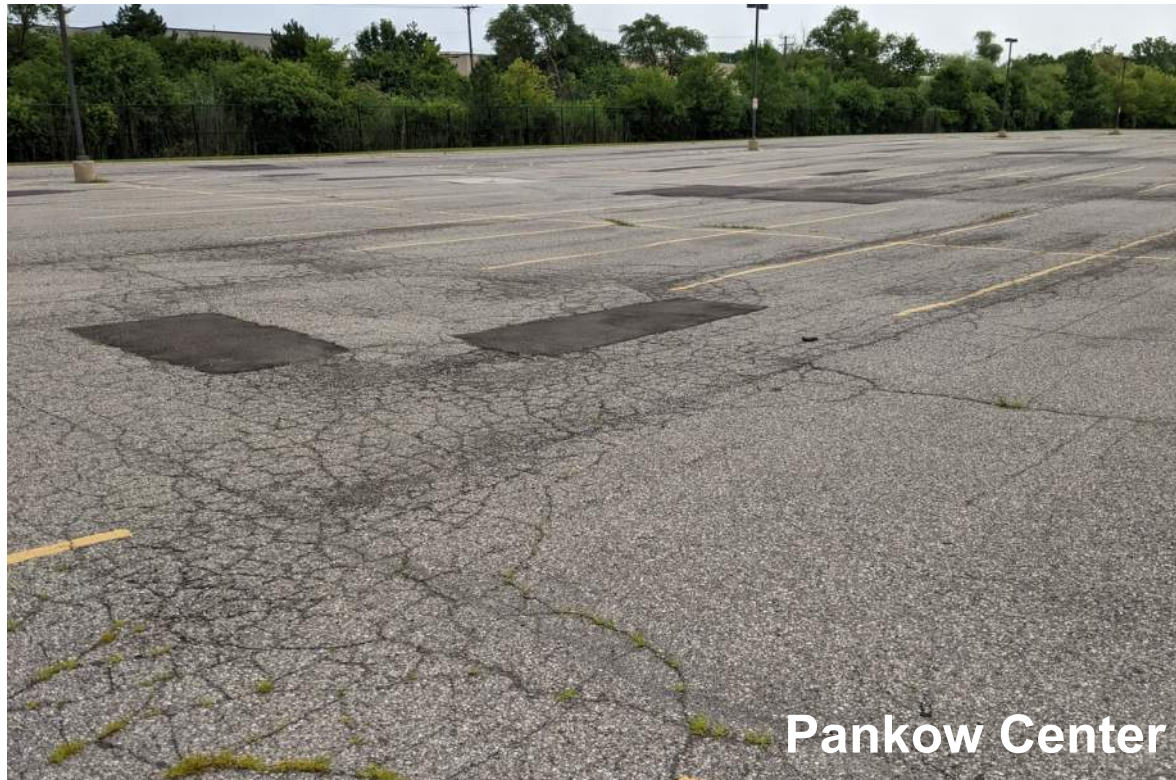
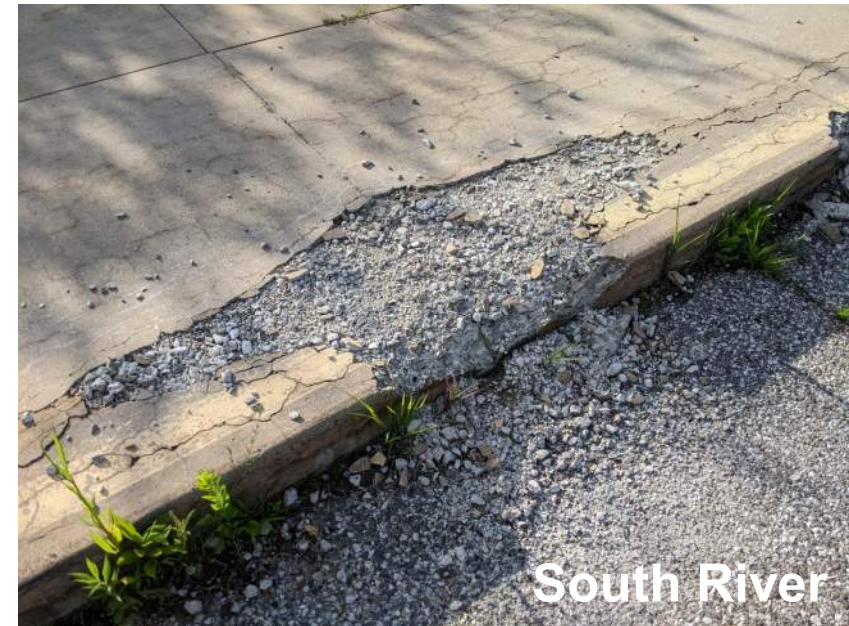
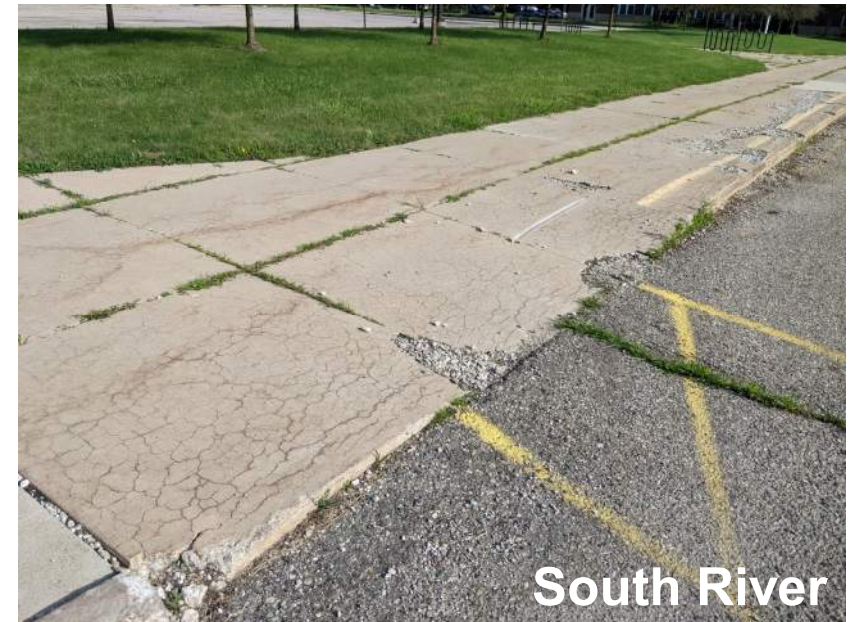
- **Paving:** Deteriorated parking areas, cracks, potholes, etc., concrete sidewalk areas cracked and failing

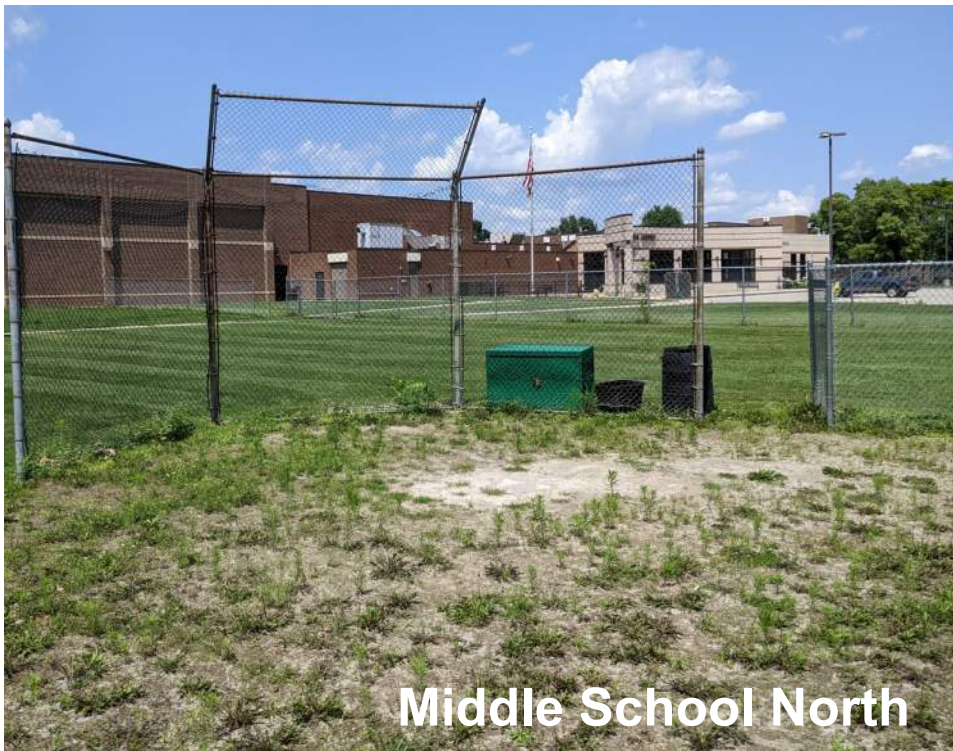
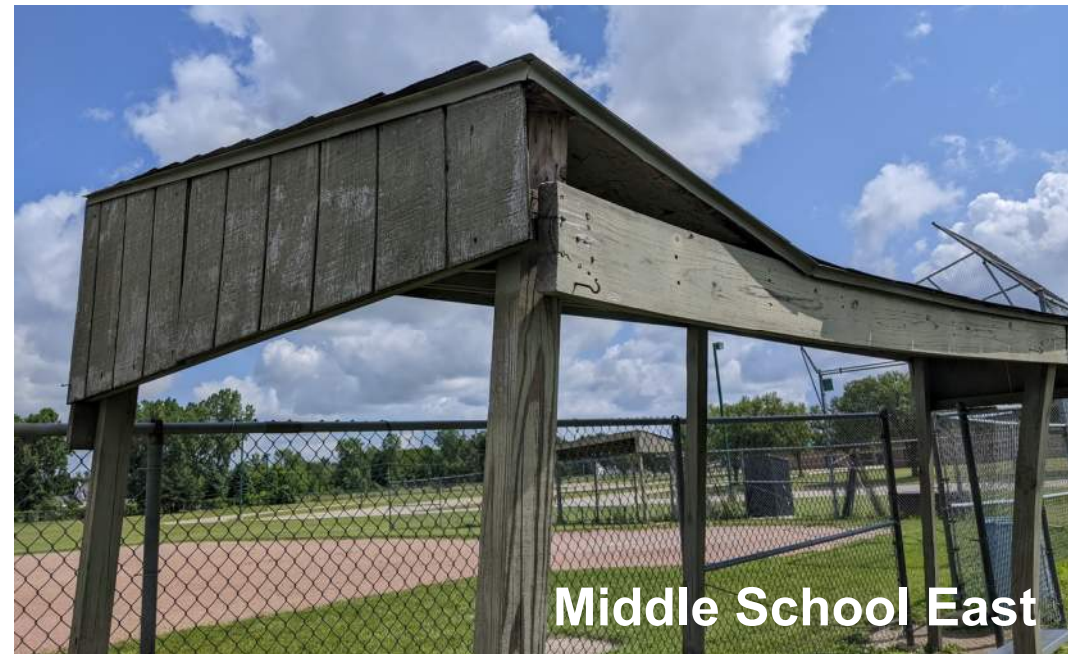
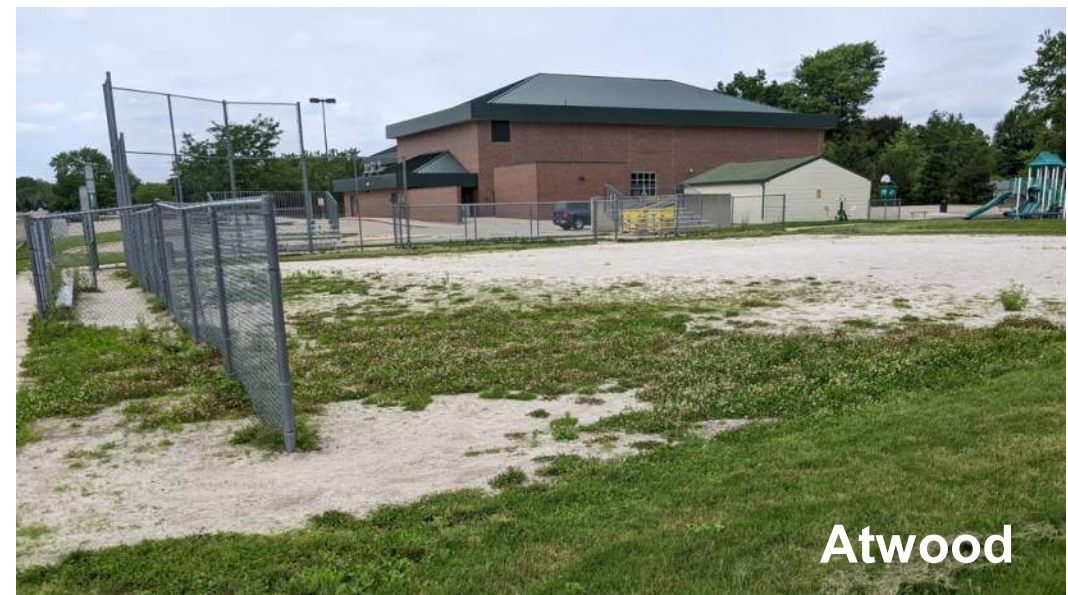
- **Playfields:** Overgrown with weeds / grass, grading & fencing issues, deteriorating dugout / bench areas

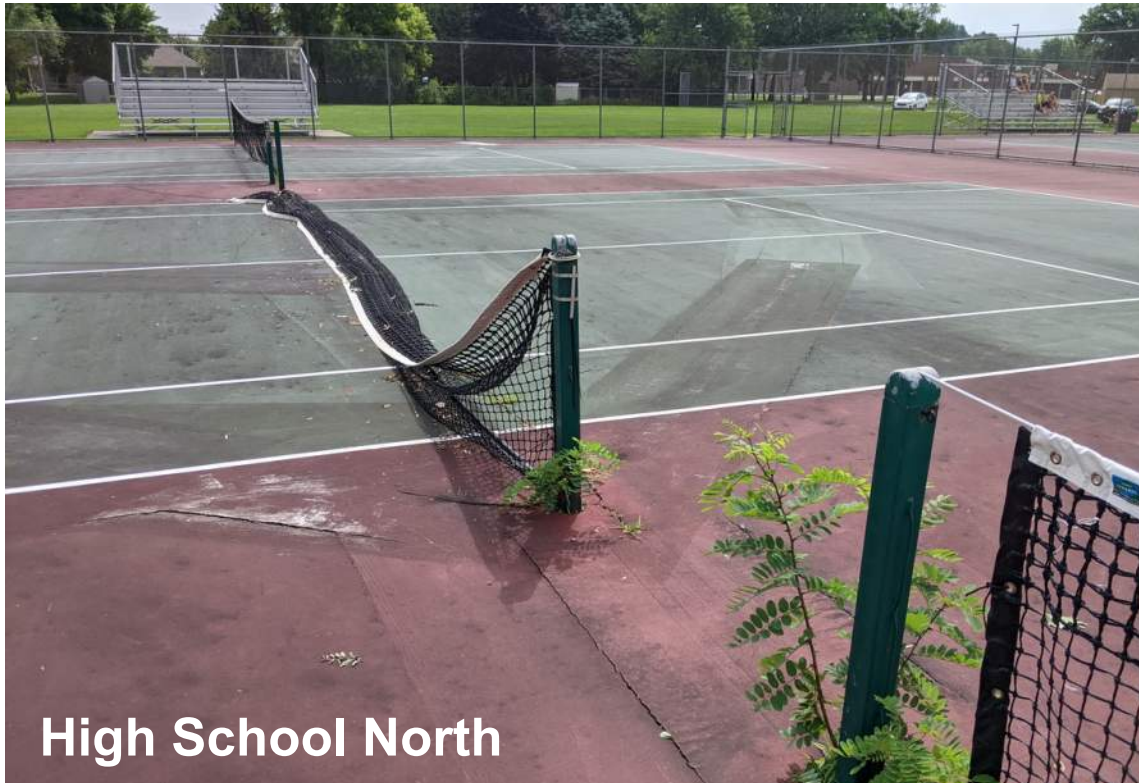
High School North

- **Tennis Courts:** Severe cracking of surface, heaving post footings, surface coating beyond useful life

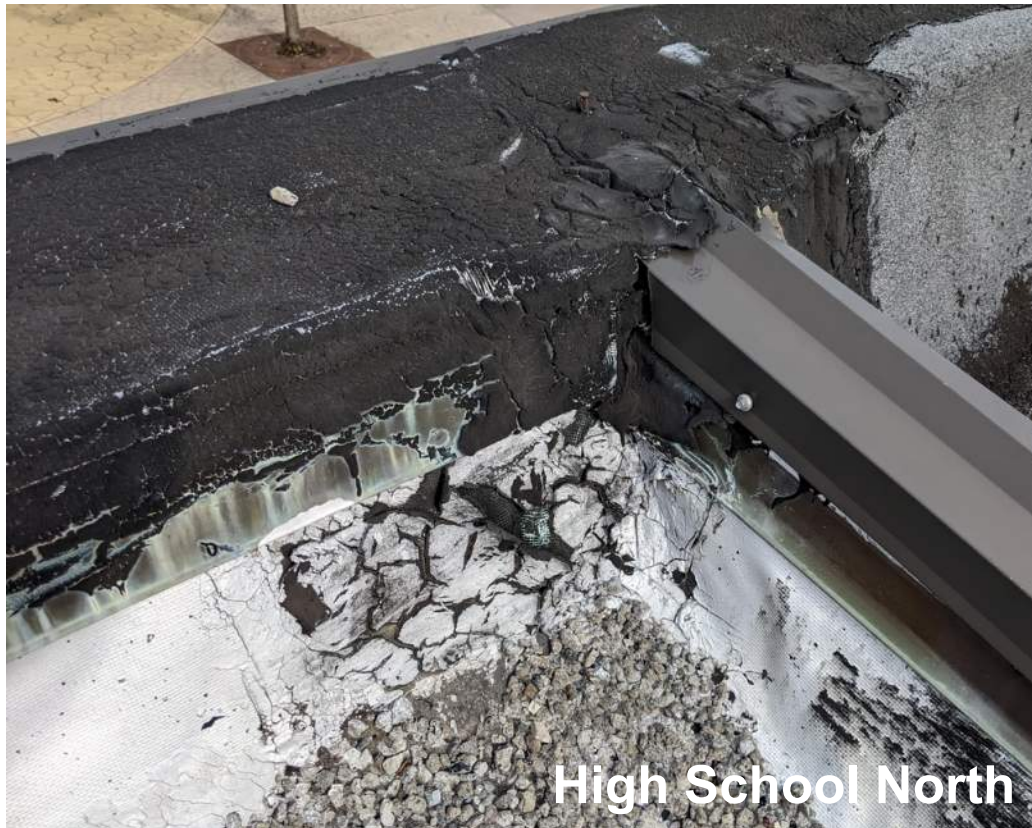
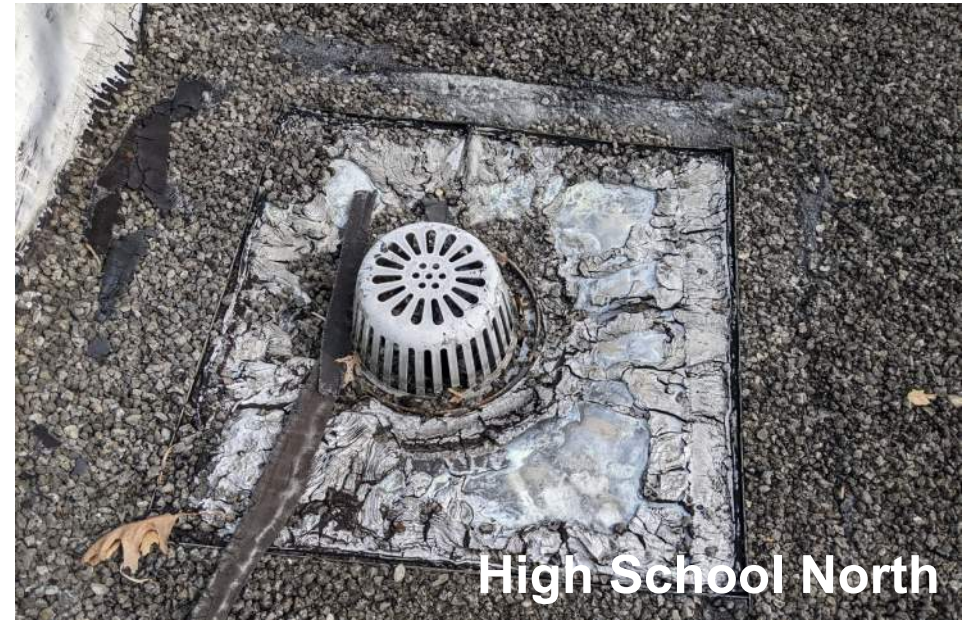
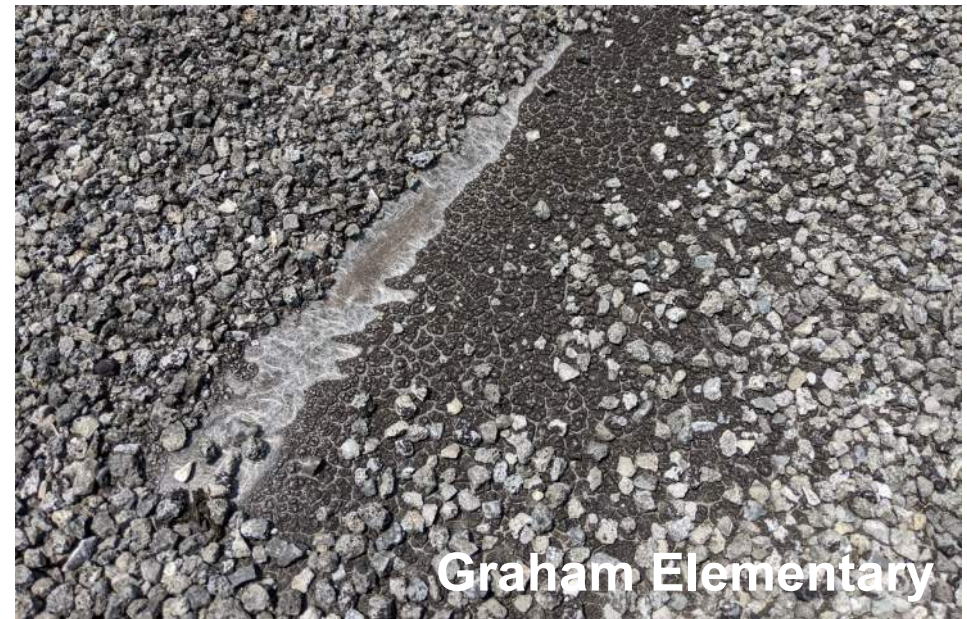
- **Roofing:** Deterioration / breakdown of surface, transition challenges

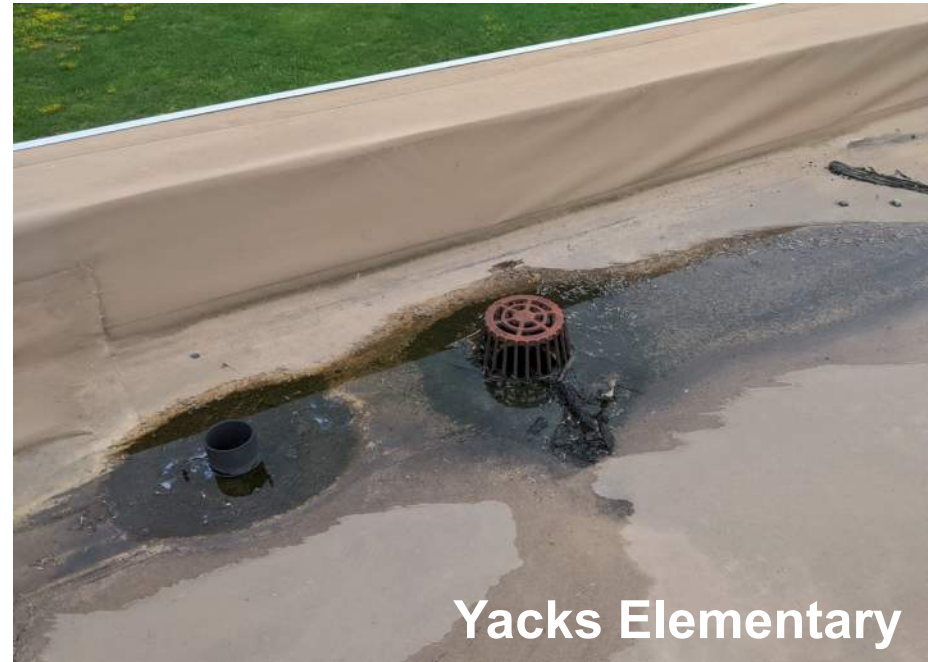
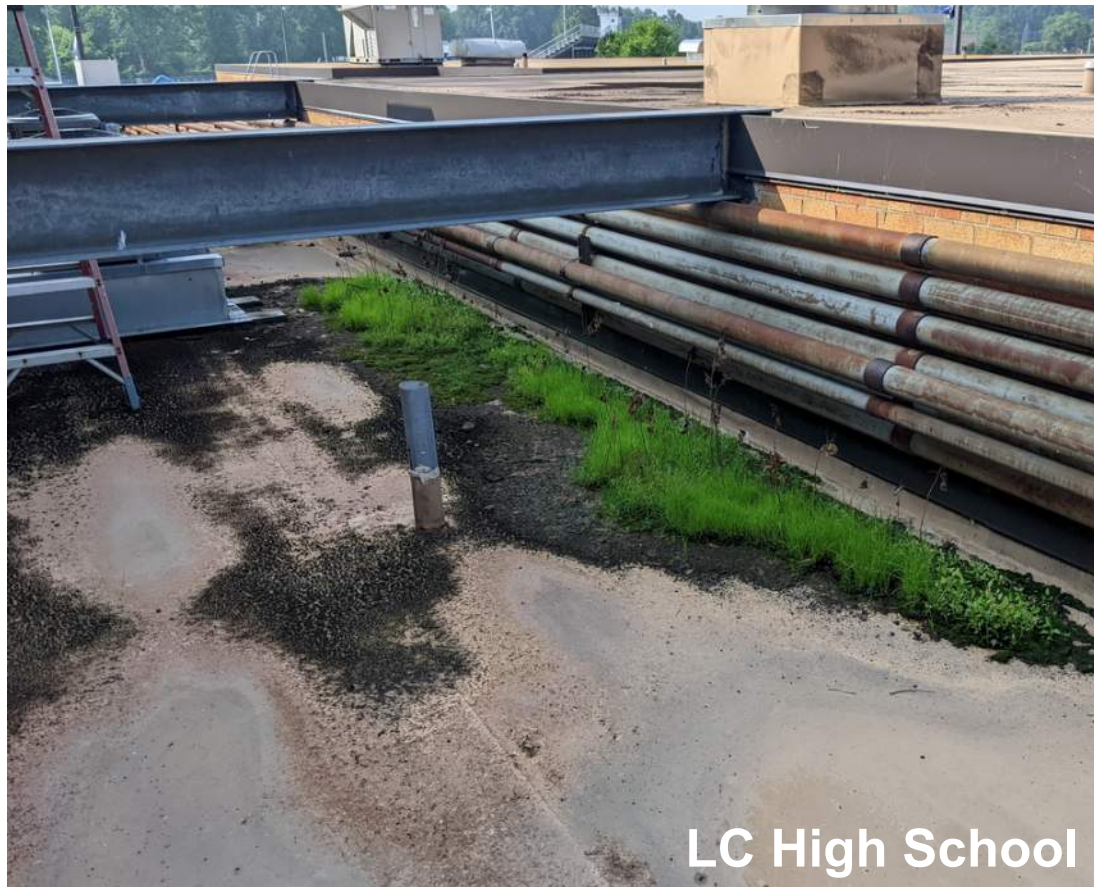
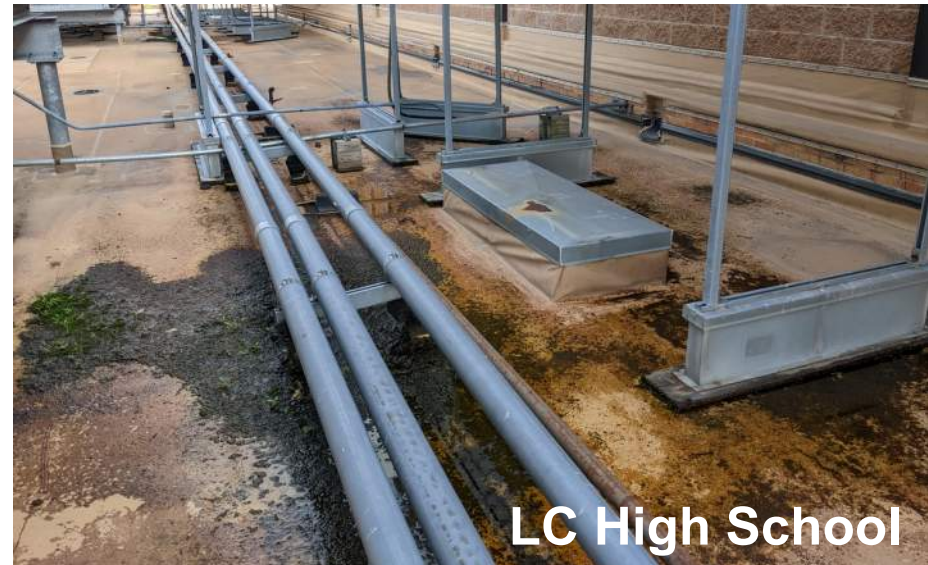
- **Roofing:** Standing / puddling water leading to vegetation growth and slippery conditions, uneven substrate boards

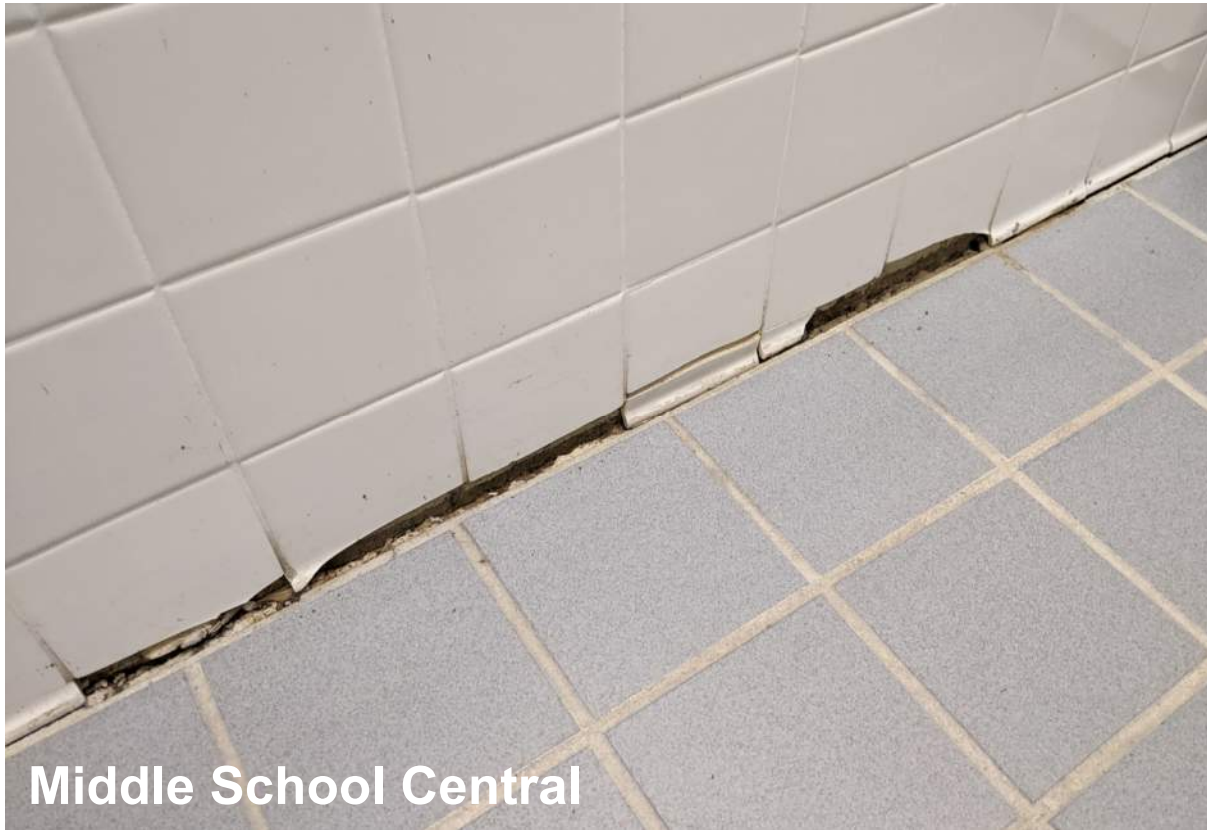
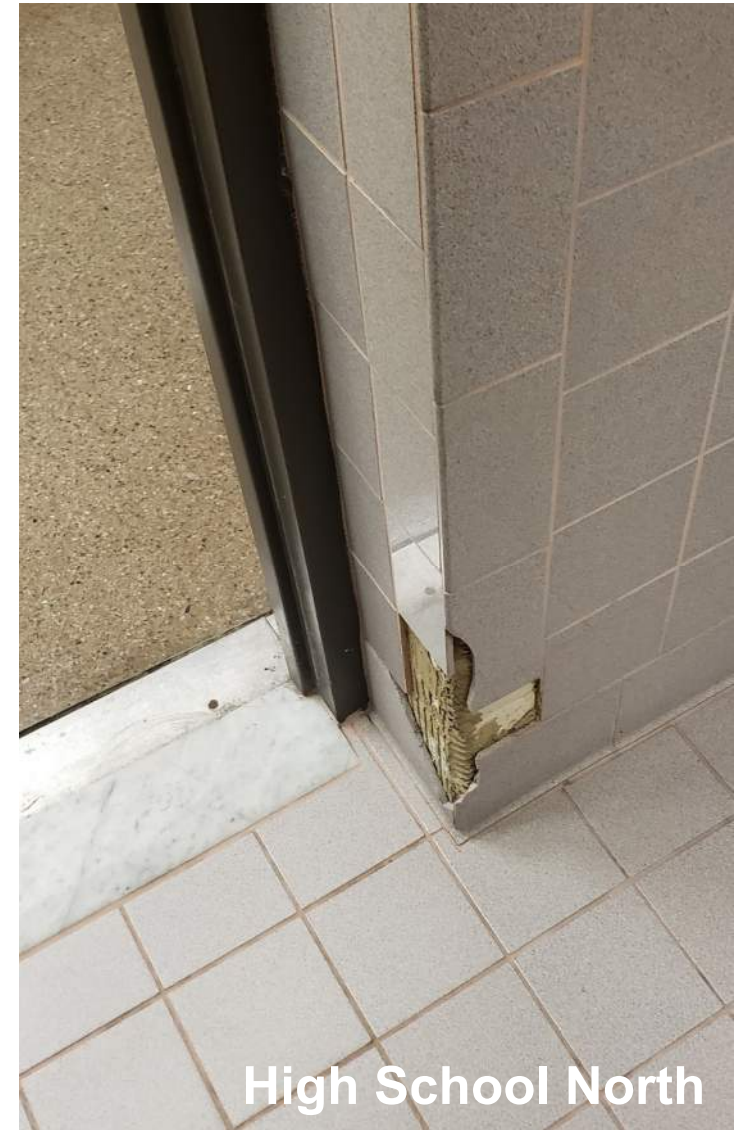
- **Restrooms:** Many of the restrooms have worn finishes, missing or broken accessories, rusted / damaged flush valves

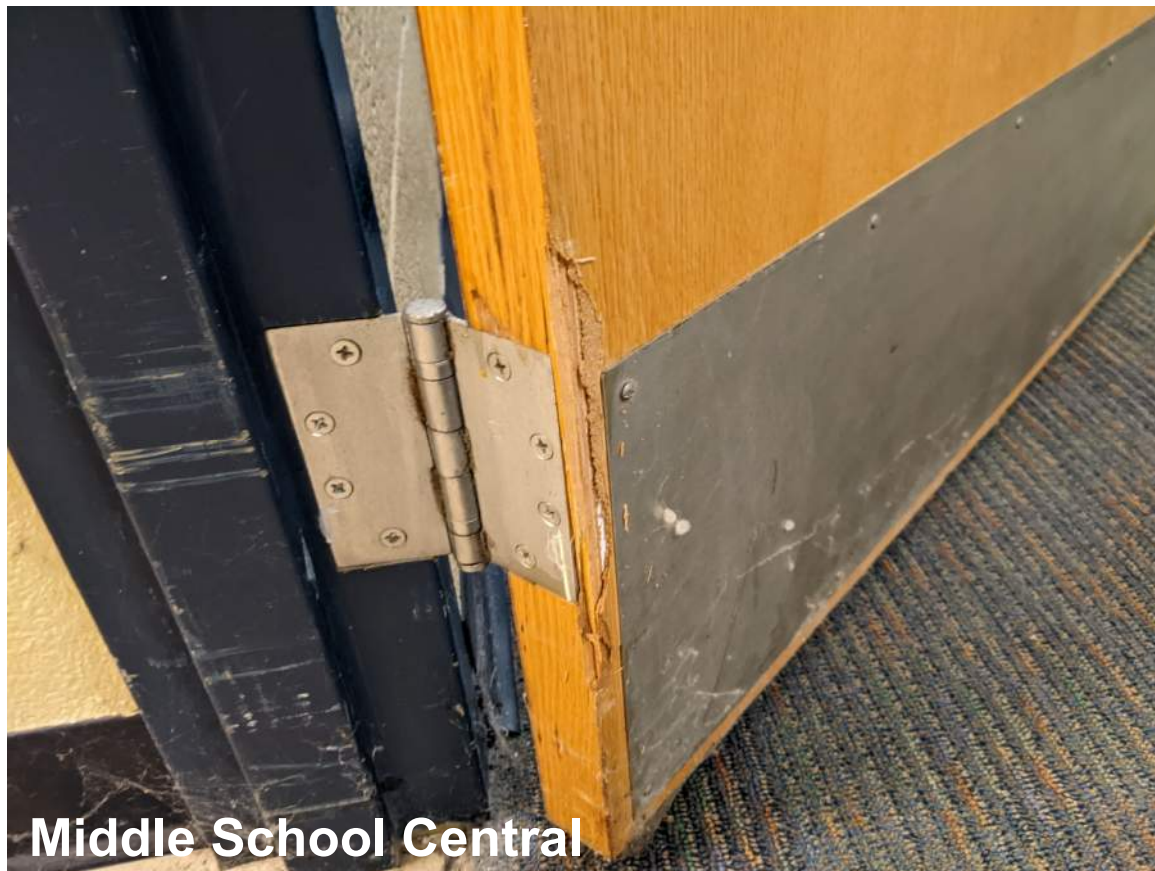
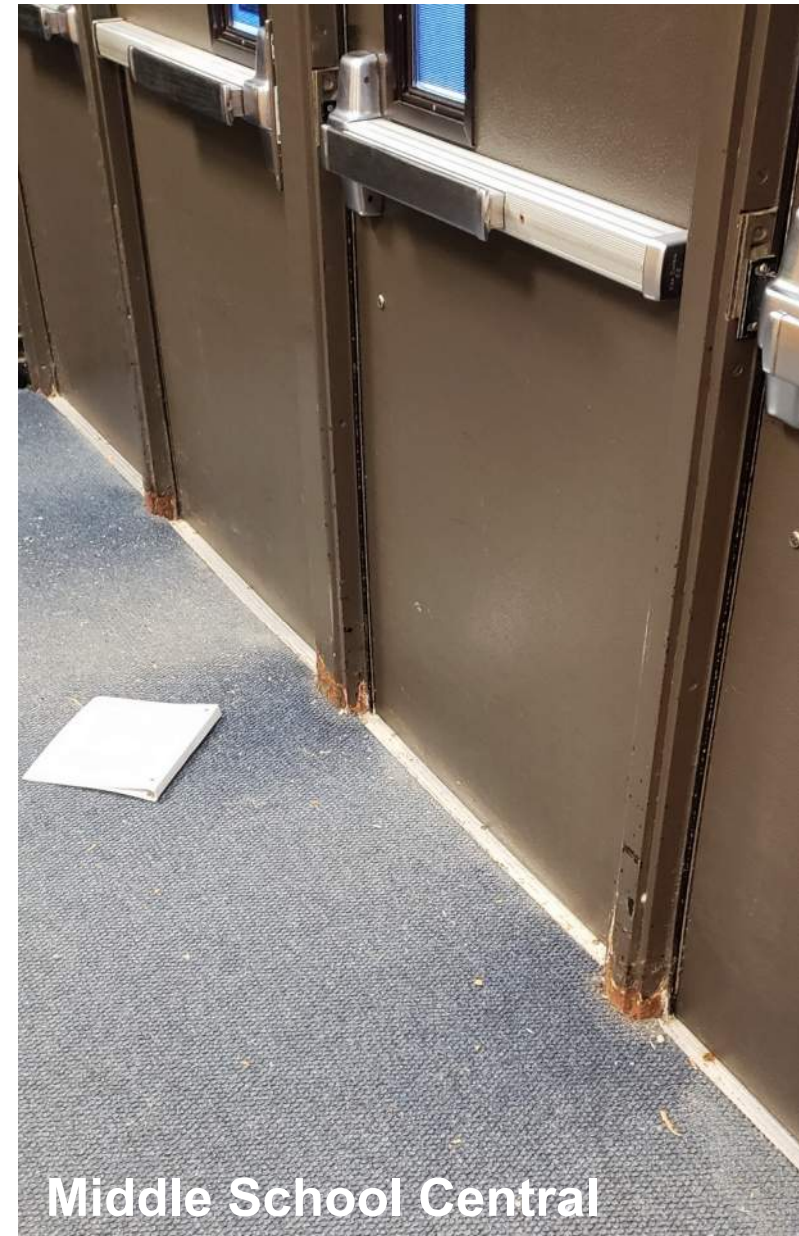
Middle School Central

- **Doors:** Some doors are in poor condition, have damaged / worn hardware, broken / rusted frames, worn finishes, delaminating veneer
