2023 Facility Assessment Overview

September 13, 2023

PARTNERS in Architecture

L'Anse Creuse Public Schools – 2023 Facility Assessment

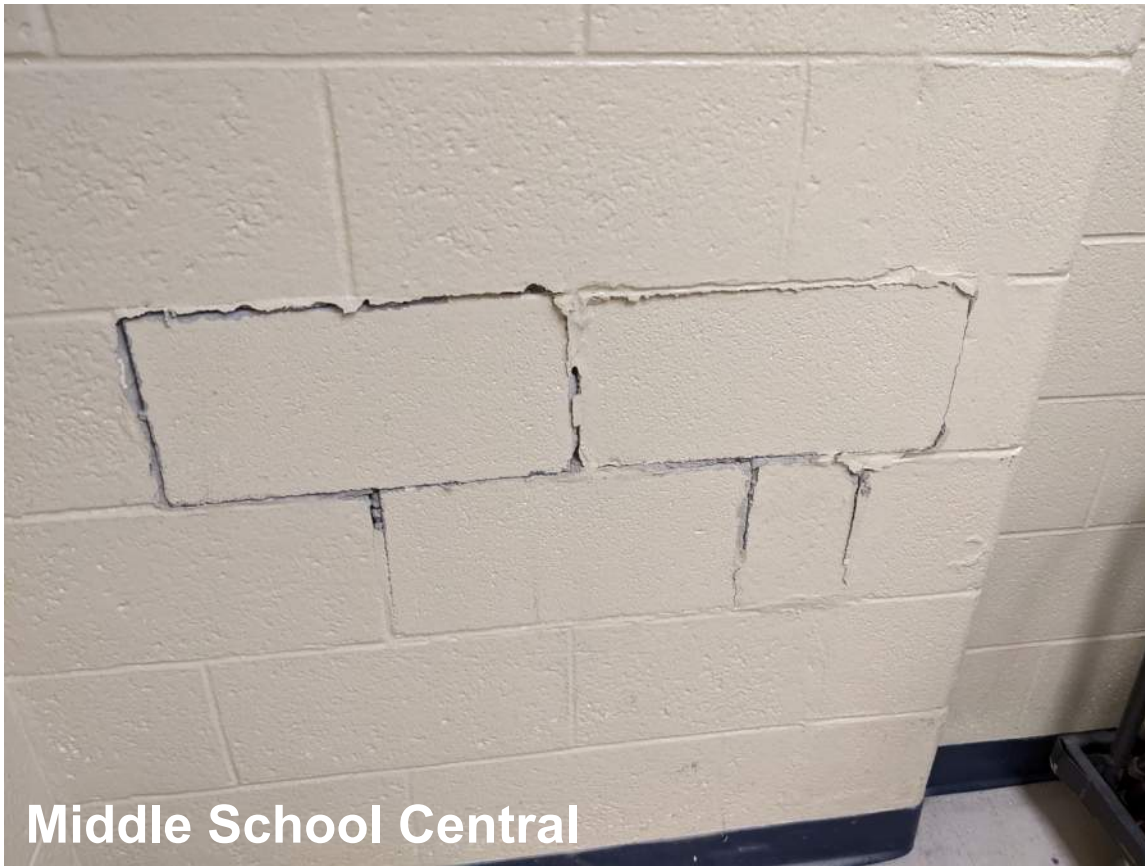
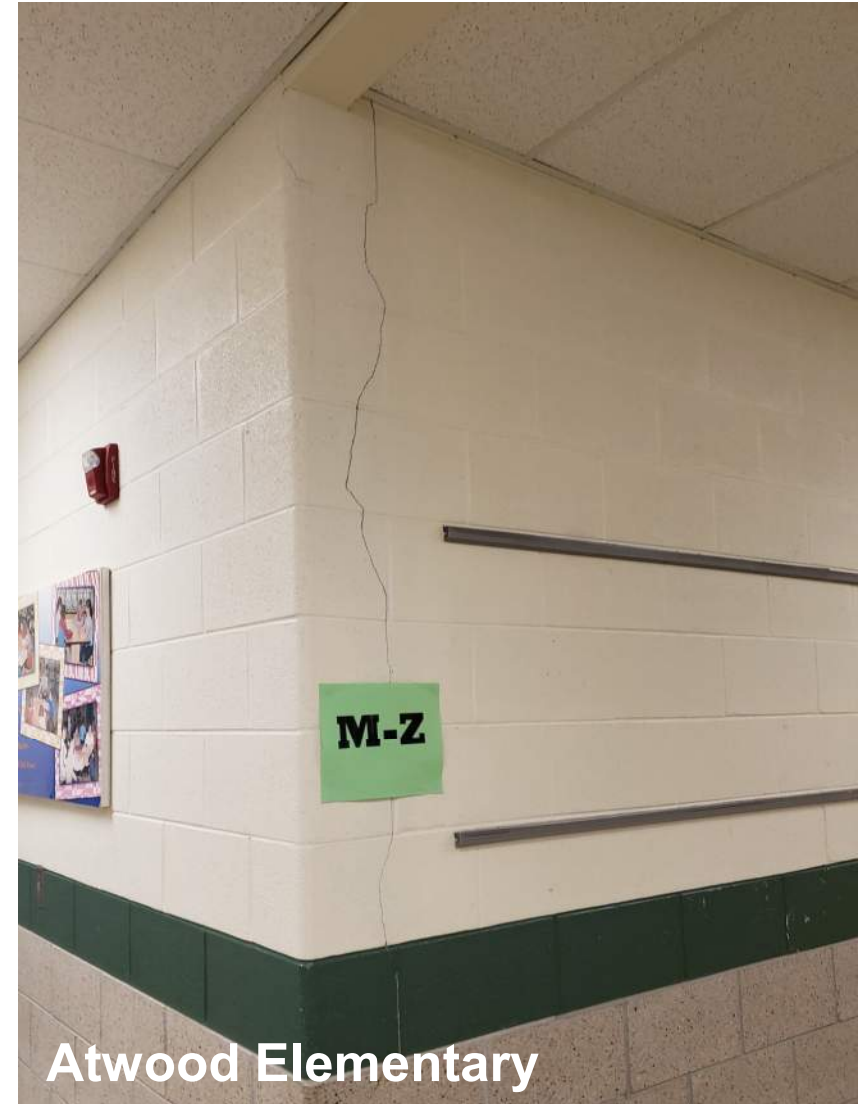
- **Walls:** Many buildings have CMU wall cracks of varying severity

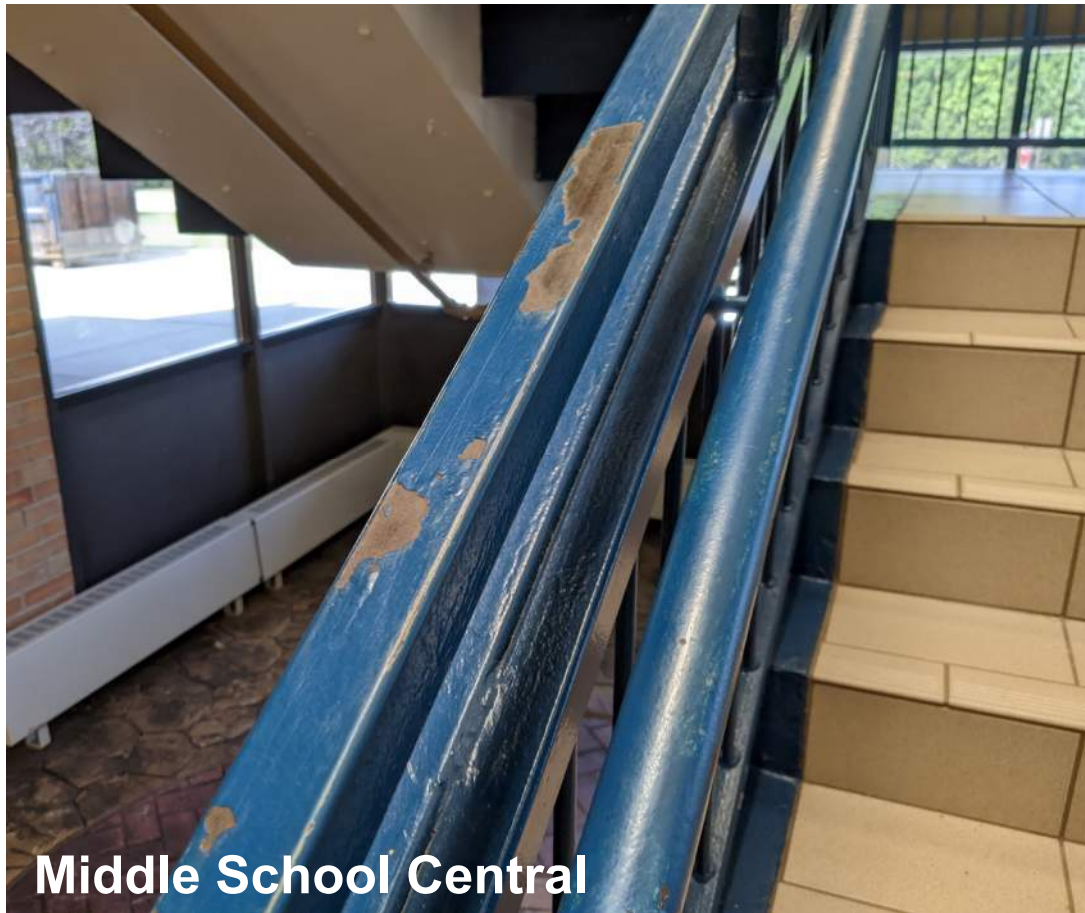
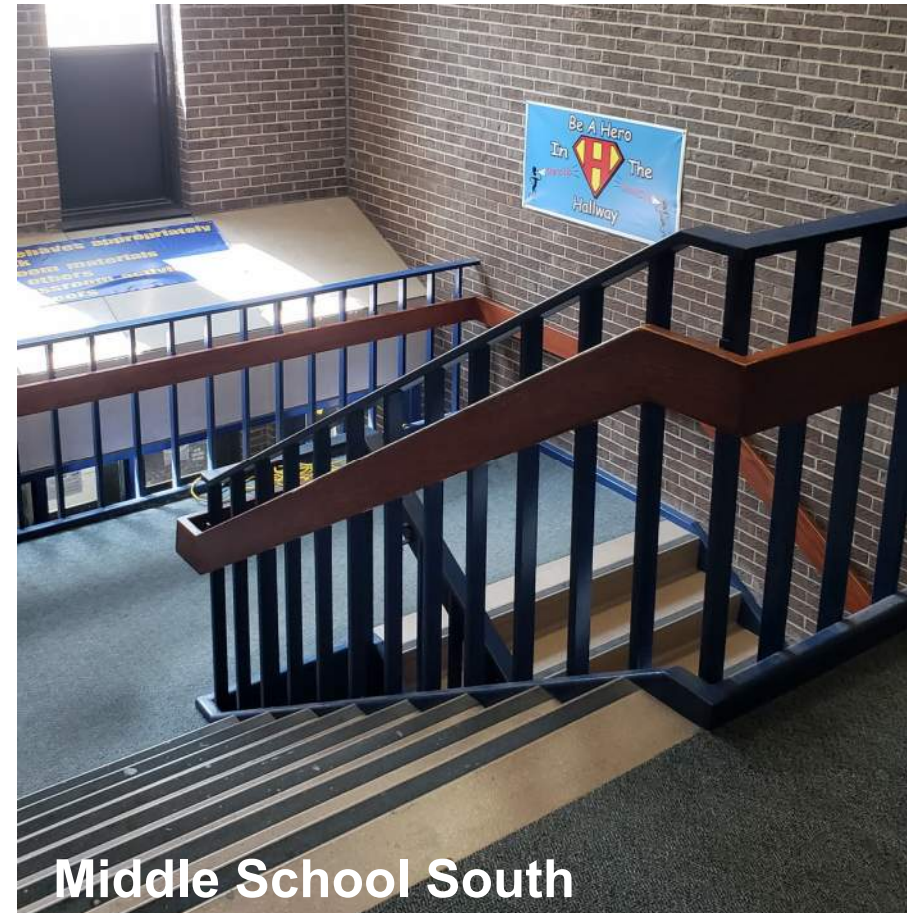
- **Stairs:** Some handrails / guardrails do not meet current code requirements, some railing finishes are scratched or peeling, some stair treads are damaged
